# Happy with natural-looking restoration

**Dr Nishan Dixit** describes a direct dental bonding case with fissure tints which restored teeth to a natural appearance

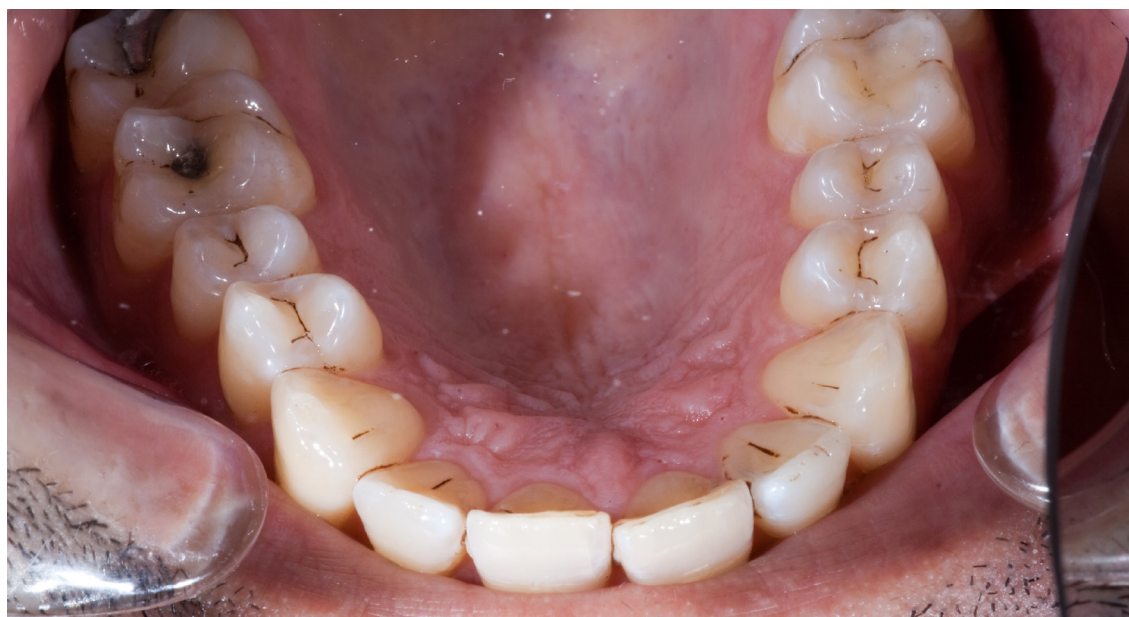
**Figure 2:** A general examination revealed the presence of multiple cavities and his teeth were heavily stained from drinking tea and coffee

A general examination revealed the presence of multiple cavities and his teeth were heavily stained from drinking tea and coffee (Figure 2). The UR6 had a failing, leaking amalgam and secondary caries. Decay was also present on the distal aspect of the UR5 (Figure 3), and was only evident radiographically.

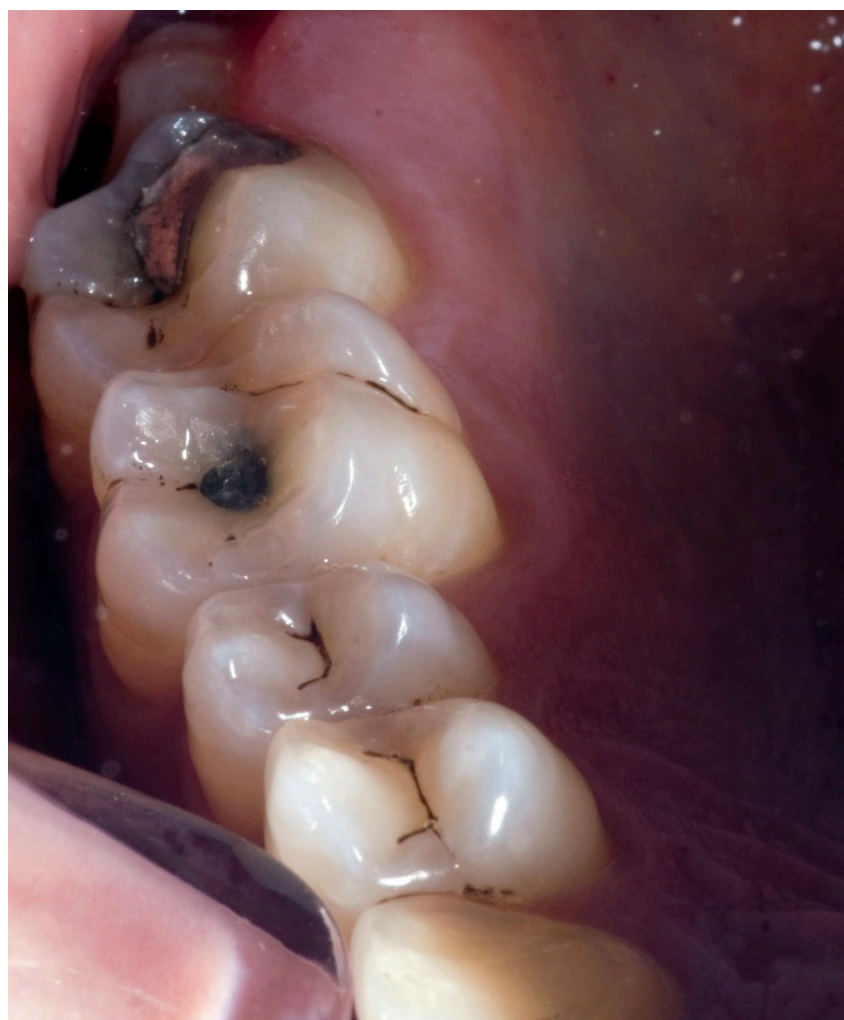
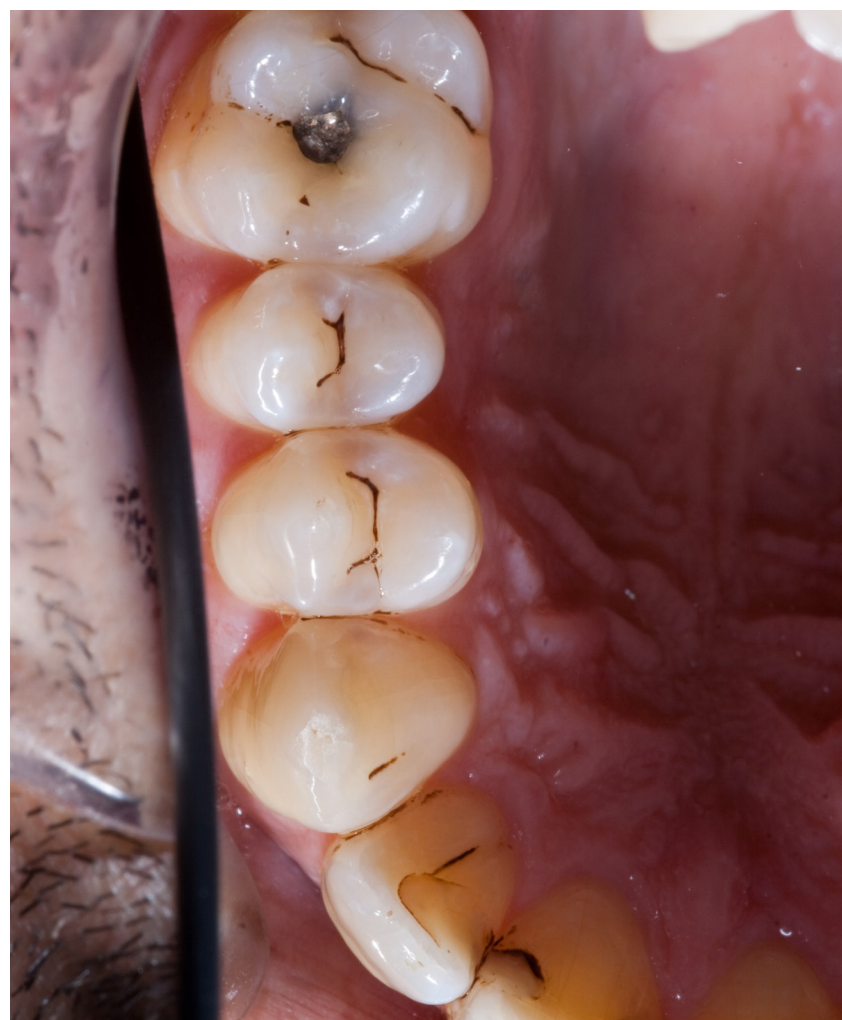
**Figure 3:** The UR6 had a failing, leaking amalgam and secondary caries. Decay was also present on the distal aspect of the UR5

After placement of rubber dam, the old amalgam and caries were removed from the UR6. Caries were also removed from the UR5, which resulted in a distal occlusal (DO) cavity. A sectional matrix system was placed on the UR5 to ensure tight contacts. Both teeth were etched with 37% phosphoric acid. They were bonded with Kulzer iBond Universal, using a selective-etch technique in accordance with the manufacturer's instructions. I find that iBond is easy to apply and produces no sensitivity.

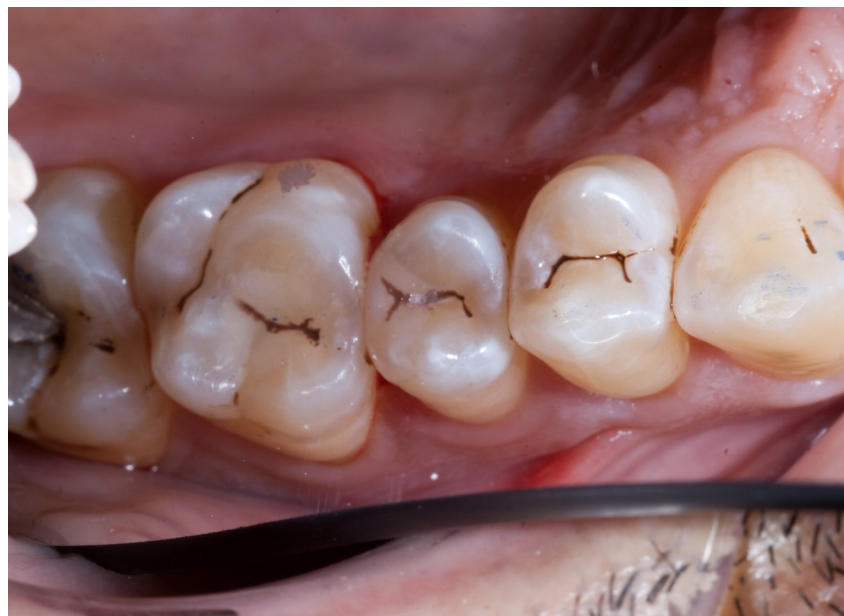
**Figure 4:** Venus Color Choco tint was used to recreate the fissure pattern and to match the other discoloured teeth

Venus Pearl composite was placed with a layered approach using the opaque light chromatic (OLC) and the A1 shades. Finally, Venus Color Choco tint was used to recreate the fissure pattern and to match the other discoloured teeth (Figure 4).

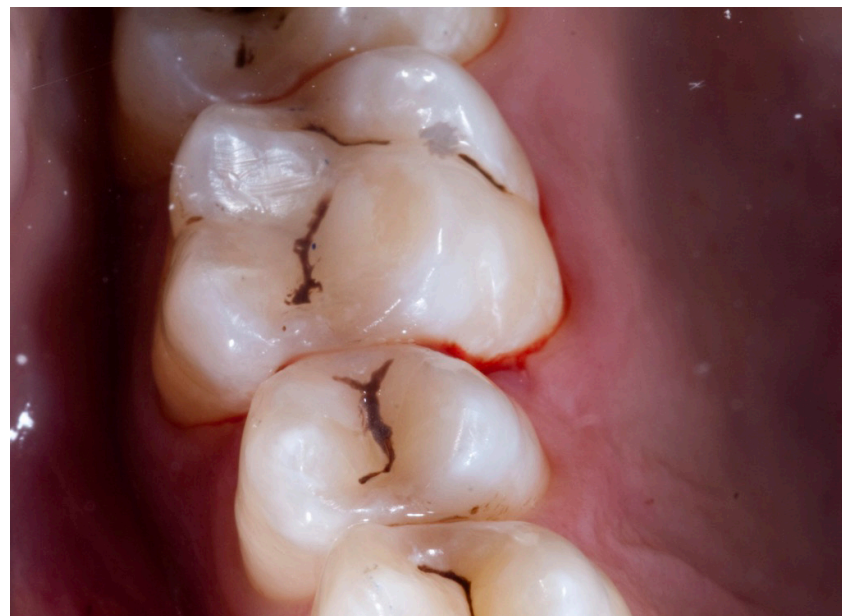
**Figure 5:** The patient was happy with the natural-looking result

Once fully cured, both the composite restorations were polished using the Kulzer Venus Supra polishing kit which gives a long-lasting, glossy shine with minimal material abrasion. Secondary polishing was completed with aluminium oxide paste and a felt-coated polishing point, which gives the restoration an extremely high lustre.

I was pleased that the damaged tooth tissue could be restored by mimicking nature as closely as possible. The patient was also happy with the natural-looking result (Figure 5), and that he was now pain free. **D**
